SAND CREEK NEAR CHANNEL SEDIMENT REDUCTION

Feasibility Report

October 15, 2015

Prepared for:
Scott County, MN
Watershed Management Organization

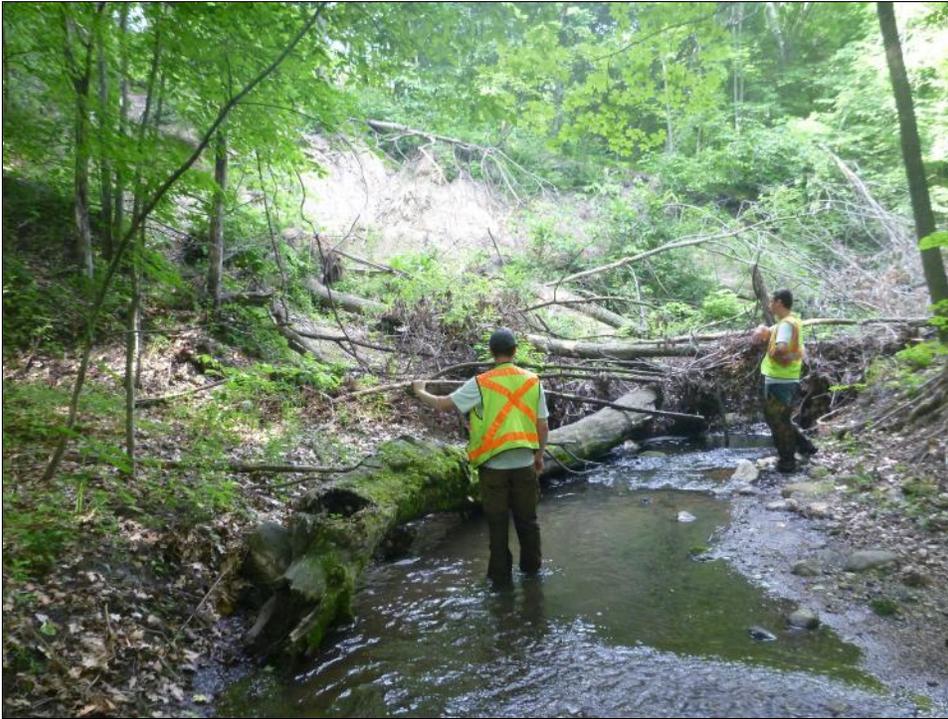
Figure 9. Woody debris accumulated just downstream of a rotational slump. Wood has created a natural “check dam” at the pinch point, blocking the channel and creating a wider, deeper, less steep ravine upstream. The debris attenuates larger flows and stores water and sediment.

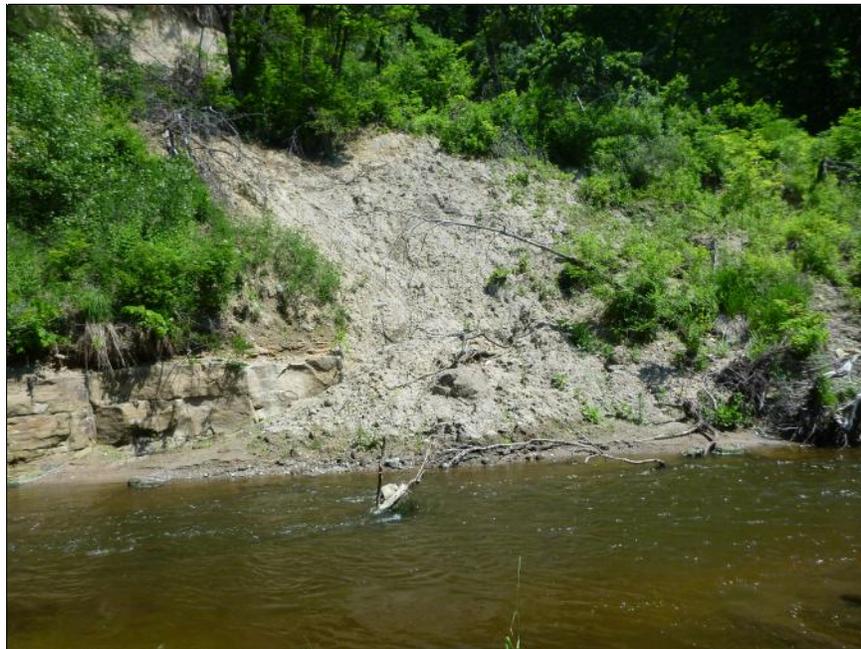
The Helena-Broadway Bluff Site consists of multiple rotational hillslope failures that currently release sediment to Sand Creek (Figure 17). The site lies at the outside of an eastward bend in Sand Creek. Bedrock was observed flanking the impacted bank, immediately downstream of the site, and it is unclear how far the bedrock extends upstream. Historic photos indicate the toe of the slope erodes at the upstream end of the bluff, which may trigger slope activity. In addition to the main scarps, the slope face includes numerous smaller scarps, small debris flow deposits, and rilling. A water tower lies within 150 feet of the slope break at the top of the bluff.

Figure 17. Helena-Broadway Bluff. The bluff includes an upper and lower slump, and the face features smaller slumps and rills. Bedrock limits erosion at the downstream end of the bed (left).

The propped plan for the Helena-Broadway Site combines a cribwall or toe wood treatment and spaced log spur dikes on the approach (Appendix E, Sheet 2). There is no need for toe stabilization on the downstream end due to bedrock protrusion. Final design of the Helena-Broadway bluff site will include geotechnical investigation and a slope stability analysis. In this case, secondary slumps on the upper hillslope and potential seep issues could compromise toe stabilization. If bedrock limits the installation of log piles, a constructed cribwall may not be an appropriate treatment and alternative measures, such as drainage modification, rock toe, or rock weirs will be examined.

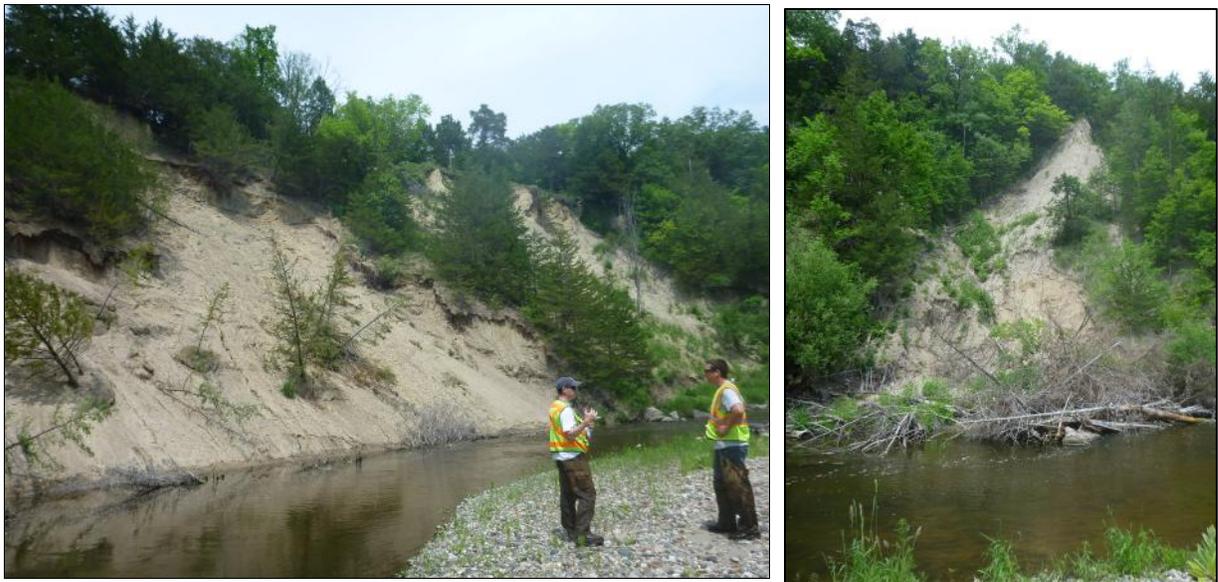
The Sawmill Lane bluff site is a high, steep, sandy bluff along a large bend in the river (Figure 8; Figure 18). The bluff face is lined with small, leaning trees, rills, and sediment cones. A cobble bar lies at the inside of the bend and sand and gravel has deposited downstream. At the upstream end of the site, a woody debris jam forces flow away from the bank and protects the vegetation growing on the toe of the slope behind and immediately downstream (Figure 19).

Figure 18 (left). Sawmill Lane Bluff Site featuring shallow slope failures, leaning trees, sediment cones and rills. A large cobble bar has formed on the inside of the bend (right).

Figure 19 (right). Existing debris jam at the toe of Sawmill Lane Bluff. The jam forces flow away from the bank and protects vegetation downstream and behind the wood.

We propose a series of spur dikes constructed from small jams (Appendix E, Sheet 3). The effect of the existing woody debris analog on site and roughly half of the bend planform is straight indicates spaced log jam spurs could be used effectively to reduce toe erosion and encourage deposition and vegetation growth. Some excavation of the existing mid-channel bar may also be required.

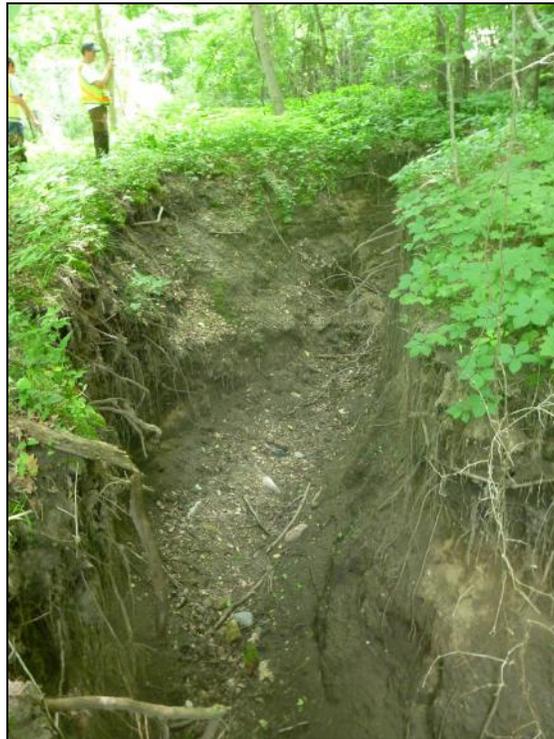
Of the six sites selected for potential projects, the W 210th St -South Ravine, is the only ravine site. The ravine runs along an abandoned road, and shows signs of recent incision. Valley wall erosion is evident along the entire reach, including both toe erosion and slumping along upper banks. The downstream end of the channel is an actively incising gully only 5 feet wide, but over 8 feet deep. This gully will likely widen over time, releasing a significant amount of sediment into Sand Creek (Figure 20). The road provides excellent site access.

Figure 20. Narrow ravine channel at the downstream end of the W 210th St – South Ravine.

The solutions proposed in the concept drawings include WASCORB or detention basin installation at the headwaters and channel widening and check dam installation downstream (Appendix E, Sheet 4).

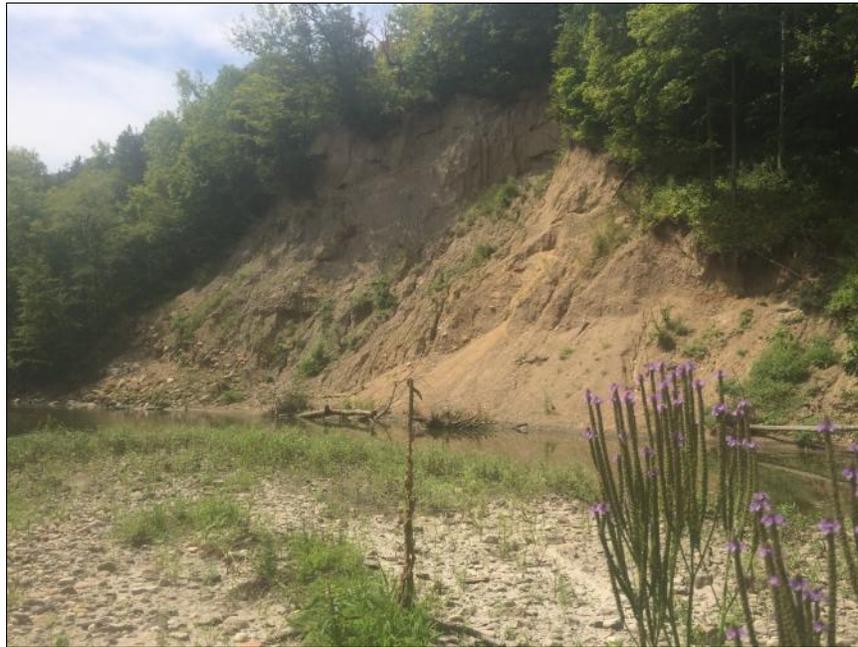
This bluff site lies at the downstream end of a relatively steep, straight reach of Sand Creek, directly before the channel bends to the west (Figure 8). The upstream end of the bluff deposit includes a bouldery channel deposit, which may help protect the bluff, whereas the downstream end is predominantly sand (Figure 21). A large, sandy, cobble bar at the base of the slope directs low flows to the inside of the bend, but erosion along the downstream, east bank indicates high flows have sufficient shear to move material (Figure 22). Historical photos indicate the channel has migrated significantly at this location.

Figure 21. 210th St W – North Bluff.

The proposed solution (Appendix E, Sheet 5) involves a cribwall stabilization of the steep bluff toe, including creation of a low profile floodplain bench consistent with the downstream bankfull depth. Stabilization of the lower end of the project area would include either placement of strategic roughness elements (log jams) that force flow away from the eroding bank, or a toe wood treatment along the eroding bank. If this site is chosen for final design, additional analysis of the downstream end of the site will be completed to ensure that the chosen treatment is appropriate.

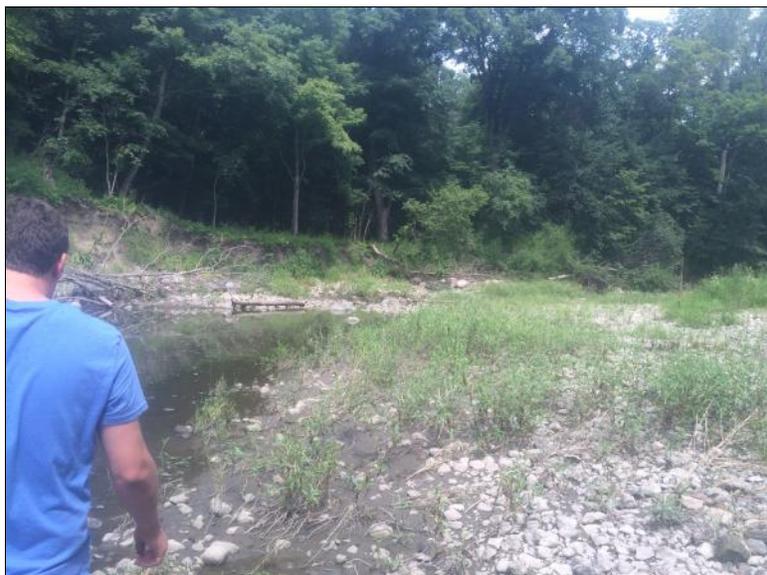
Figure 22. Cobble Bar and bank erosion downstream of the 210th St W – North Bluff

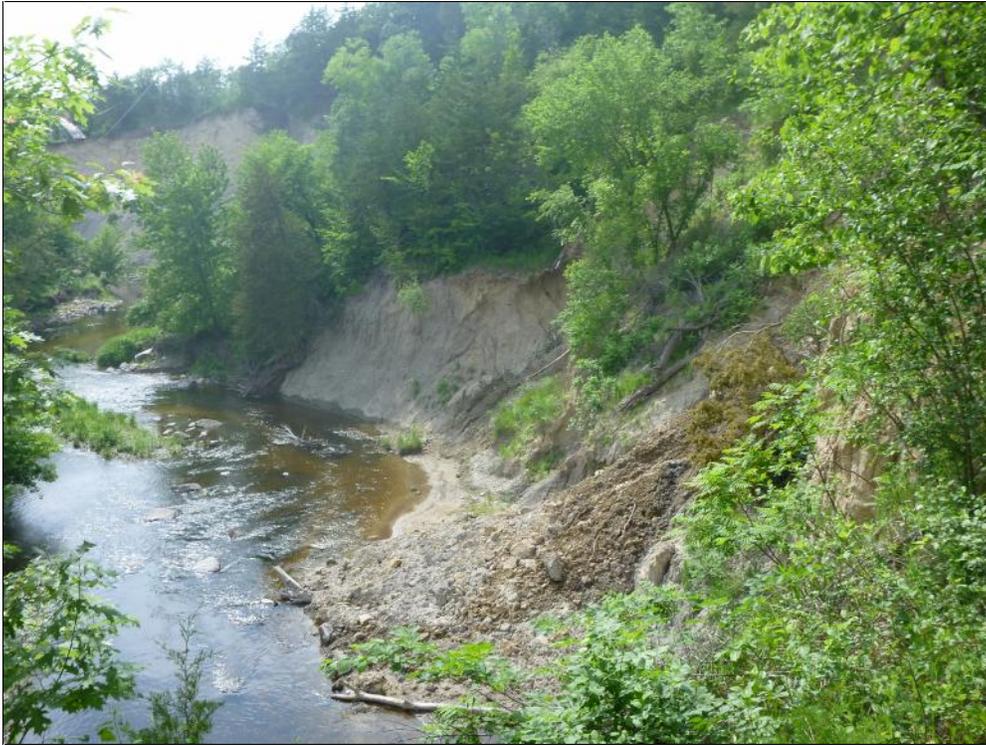
The Highway 8 – Xanadu Site is one of the highest sediment producing areas along the channel. It consists of two failing slopes. The upstream bluff recently failed and appears to be highly unstable (Figure 23). The downstream bluff is steep, with debris cones and rills along the face, but does not appear to be actively collapsing (Figure 24). The site occupies a large compound bend along Sand Creek, and the failures are likely related to toe erosion along the outside of the bend. A residence/business occupies the top of the bluff and structures are often within 100 feet of the slope break.

The Xanadu bluffs are high (60-80 ft) and very steep, with near vertical slopes in some areas. Whereas, the other project sites have no infrastructure immediately affected by slope retreat, the Xanadu site has homes and other structures built near the bluff edge. Stabilization of the toe of these bluffs may slow down further mass wasting, but the bluff tops will continue to lose material until an angle of repose is met. Continued slope retreat may be a slow process or it could occur episodically at any time. The exact stable angle of repose is currently unknown, but a range of values could be determined through geotechnical analysis. Slope stability would not be achieved without either passive or active removal of material from the top of the slope, with either case involving relocation of infrastructure. For example, if a 1.5H to 1.0V slope was desired, the top of the bank would need to be moved back 120 feet.

Figure 23. Upstream bluff at the Highway 8 – Xanadu Site. The bluff has recently failed and is relatively unstable.

The proposed treatment (Appendix E, Sheet 6) includes toe stabilization, but it is recommended that if this approach is taken, that either the slope be excavated or the infrastructure adjacent to the upper slope be moved to allow for natural failure of the upper slope. We have not included active excavation design in the concept plans, but excavation is included in the estimated costs for the project (Appendix E).

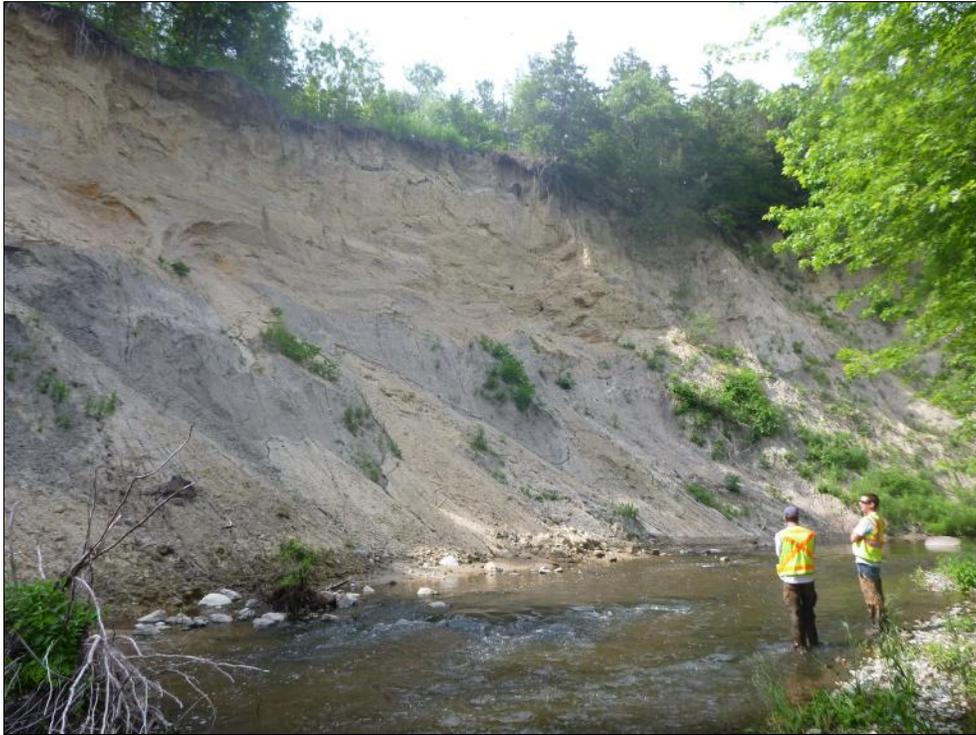
Figure 24. Downstream bluff at the Highway 8-Xanadu Site. Sediment cones and rills line the bluff face.
