# Credit River, MN

## Final Report - Fluvial Geomorphic Assessment

March 5, 2008

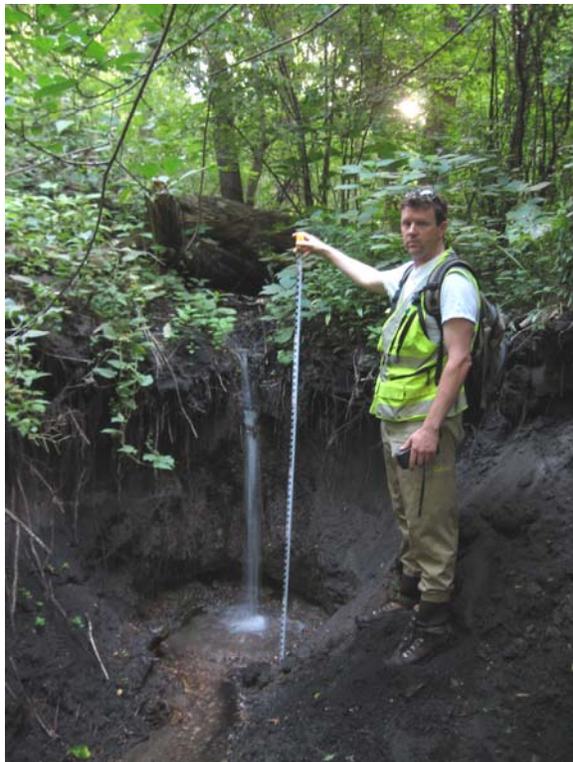
Figure 2: A headcut and incised channel on Tributary 1 of the Credit River.

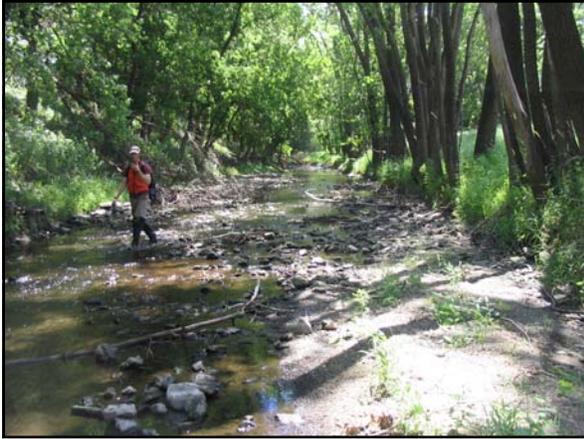
Figure 12: Reach 1 of the Credit River; station 1750 looking upstream. Notice the high berm on the left side of the photograph (river right).

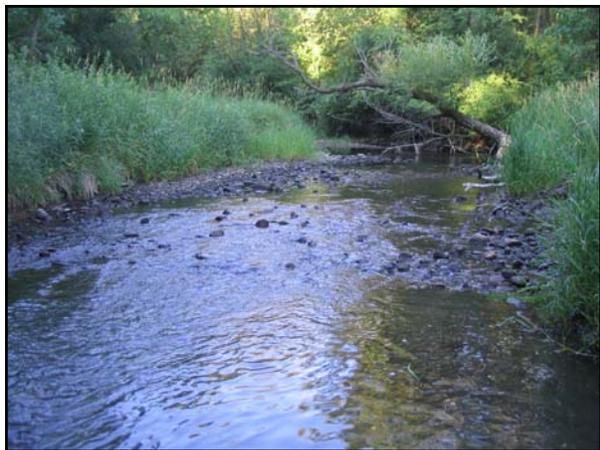
Figure 14: Reach 2, Subreach 2, station 6600 looking upstream.

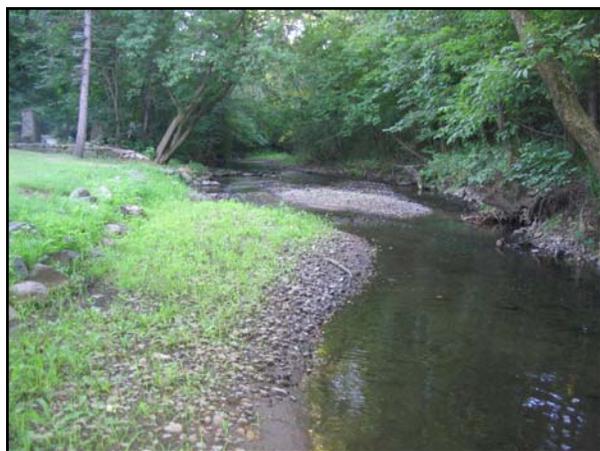
Figure 15: Reach 3, station 9000 looking upstream.

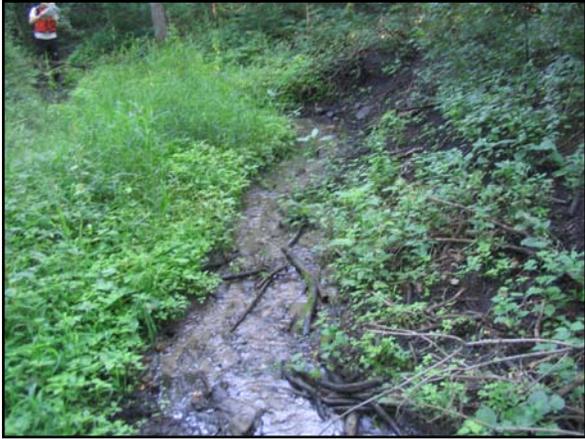
Figure 16: Tributary 1 looking downstream; confluence with Credit River is at station 10100.

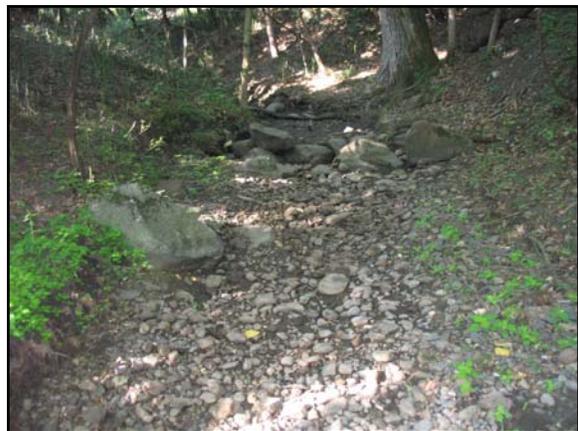
perched 2.5 feet on the downstream side, and much of the riprap that was placed to stabilize the banks has been washed downstream. Active progression of successive headcuts has caused the channel to down cut roughly 5 to 6 feet. This incision has, for the time being, been slowed at Utica Avenue, but the crossing is in danger of failure due to future incision and subsequent erosion around the outlet. Previous reconstruction of the channel has occurred near the Princeton Court development. Riprap was placed within the channel and along the banks, but does not appear to have accounted for incision, and does not include any visible gravel or fabric filter component. Riparian vegetation was removed and the right bank is managed for turfgrass, although the degree of incision is independent of vegetation treatment in this case. Much of this riprap has been moved by high flows and downcutting, and is no longer providing the designed stability. The lack of riparian vegetation has reduced bank stability and canopy cover.

Figure 17: Tributary 2 looking upstream; confluence with Credit River is at station 15700.

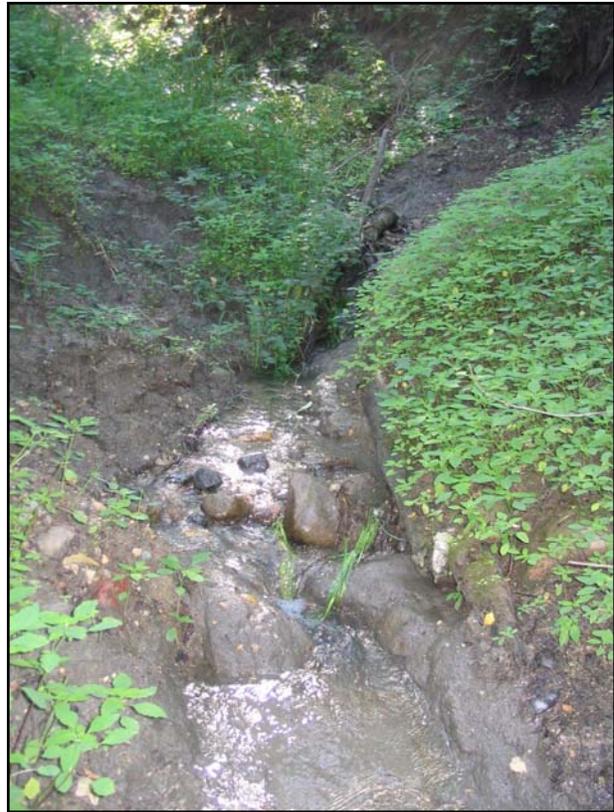
Figure 18: Tributary 3 looking upstream; confluence with the Credit River is at station 17500.

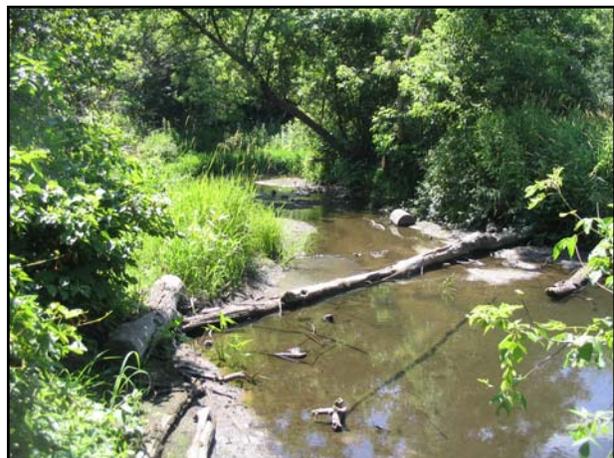
Figure 19: Reach 4, station 30500 looking upstream.

degradation. Additionally, two small stone dams crossing the channel are fish passage barriers at low flows.

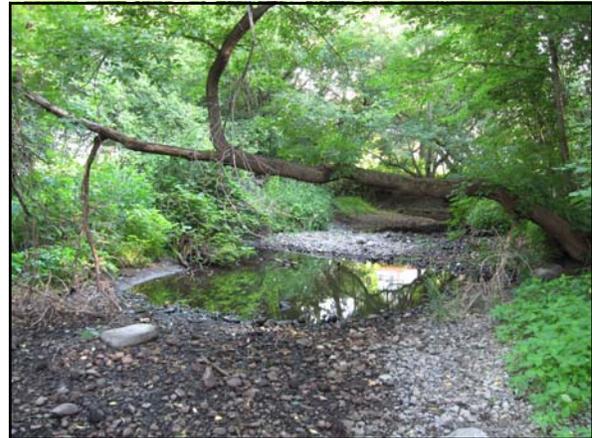
Figure 20: Reach 5, station 35400 looking upstream. The canopy cover is diverse and includes green ash, black willow, cottonwood, elm, maple, and oak; these trees range in age from saplings a few years old to approximately 50 years old. One landowner is managing mowed turfgrass in the riparian area, but there is a narrow buffer of riparian vegetation between the lawn and the channel. Another landowner has cleared much of the undergrowth on the floodplain but has retained the overstory.

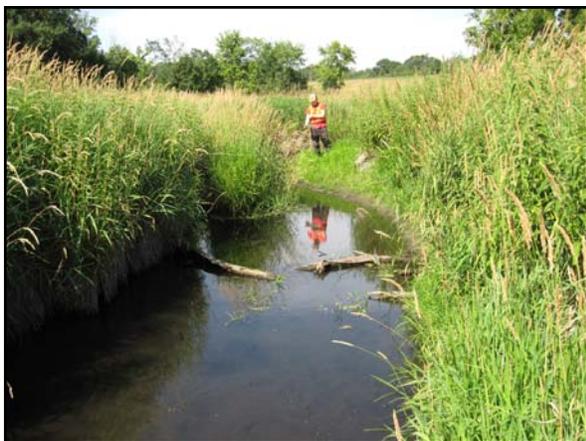
Figure 21: Reach 6, station 52300 looking upstream.

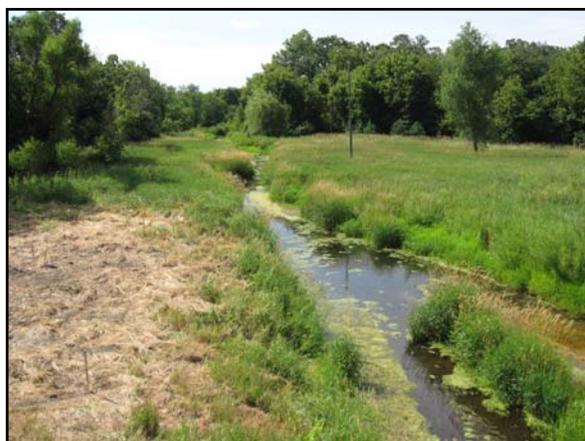
Figure 22: Reach 7, station 53300 looking upstream.

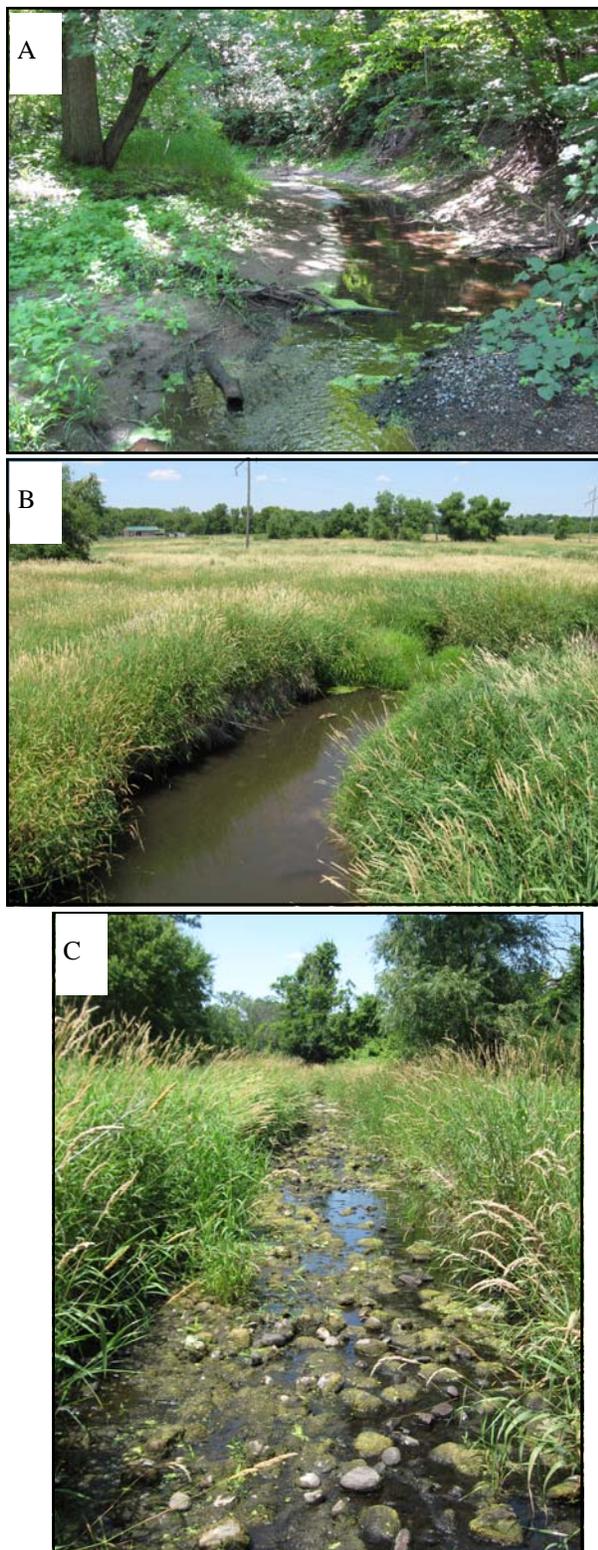
Figure 24: Reach 9, (A) Subreach 1 at station 58900 looking upstream, (B) Subreach 2 at station 63450 looking downstream, (C) Subreach 3 at station 65900 looking downstream.

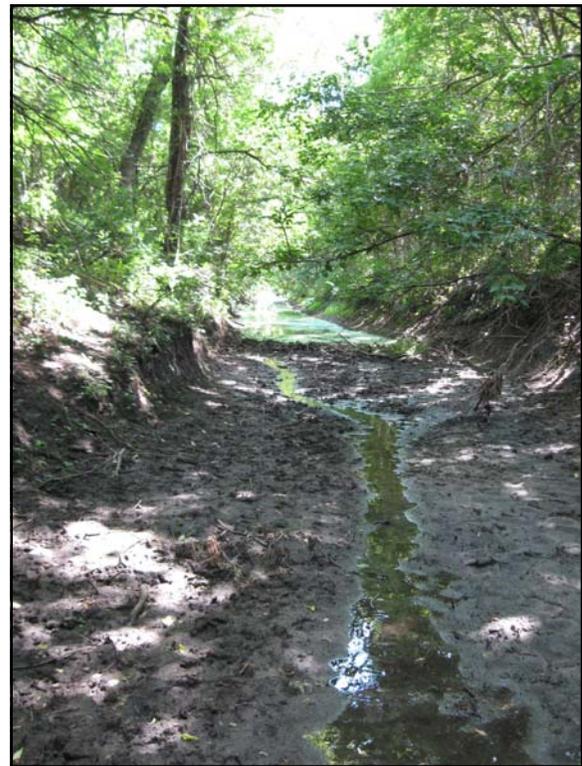
Figure 25: Reach 11 at station 71500 looking upstream. Beaver have constructed a small dam creating the pool covered with duckweed.

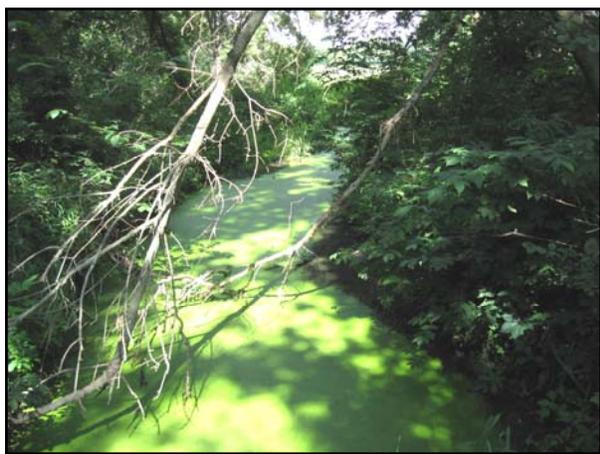
Figure 26: Tributary 6 looking upstream from dirt road that is approximately 100 feet from the confluence with the Credit River at station 73500. The former wetland is visible in the background.

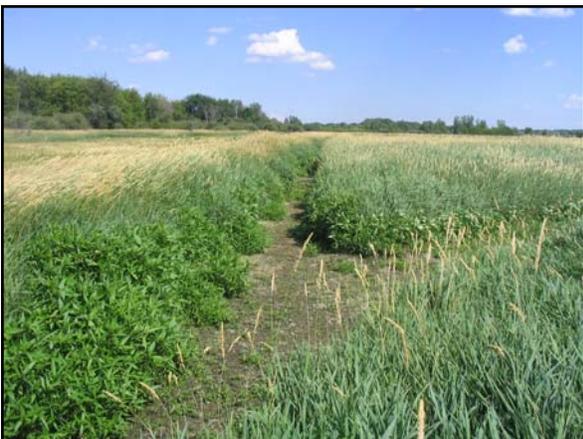
Figure 27: Reach 20 at station 116650 looking upstream.

crops and the channel. There is essentially no sinuosity, canopy cover, or channel or habitat complexity in these reaches. Two fish passage barriers in Reach 16 include a 1.5-foot concrete dam and a 7-foot culvert under County Road 8 that is perched 6 inches on the downstream end. The amount of water in these ditches is variable with dewatering likely the main cause. The channel through Reach 20 is a straightened ditch through wetland. The crop rows of the early 20<sup>th</sup> century are still visible, but the wetland is now dominated by reed canarygrass. Farming is still active adjacent to the wetland and new residential developments are currently being constructed. The channels through these straightened reaches generally have sand/silt beds with occasional cobble riffles.
