# Site Suitability for Septic Systems

Merriam Junction Sands, LLC  
on Property owned by Bryan  
Rock Products, Inc. and  
Malkerson Sales, Inc.

Stacey Feser  
FESER ENVIRONMENTAL  
MPCA License # 3907  
(612) 382-7491  
staceyfeser@gmail.com

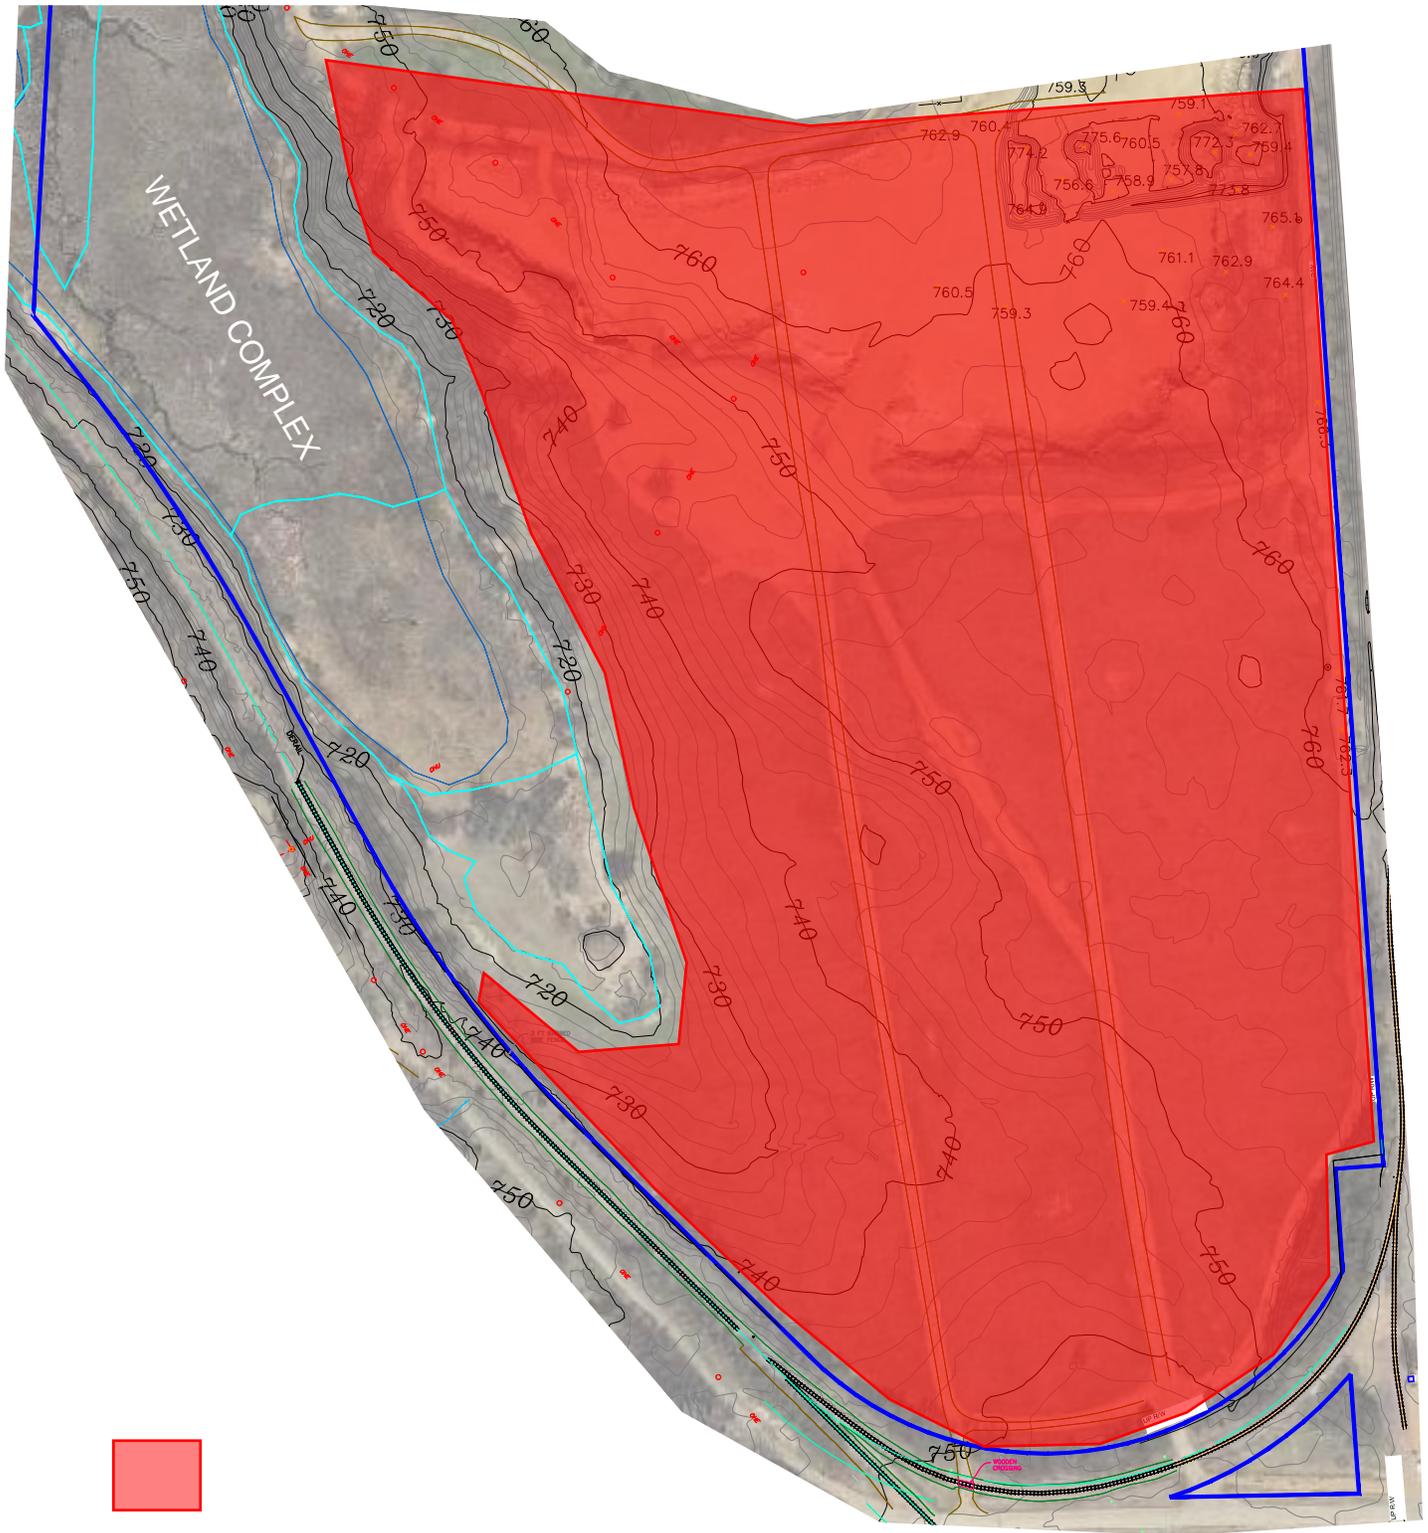
**Exhibit G -  
Renaissance Festival Parking Lot Map  
on Malkerson Sales Property**

Compacted soils were observed in this area due to over 44 years of driving and parking on the soils for the Renaissance Festival. There were also many areas where limestone was visible at the surface, with less than 12 inches of soil depth to the limestone. This area would not be able to support any Type 1 SSTS sites (Exhibit G).

Not suitable  
for Type 1  
SSTS Sites

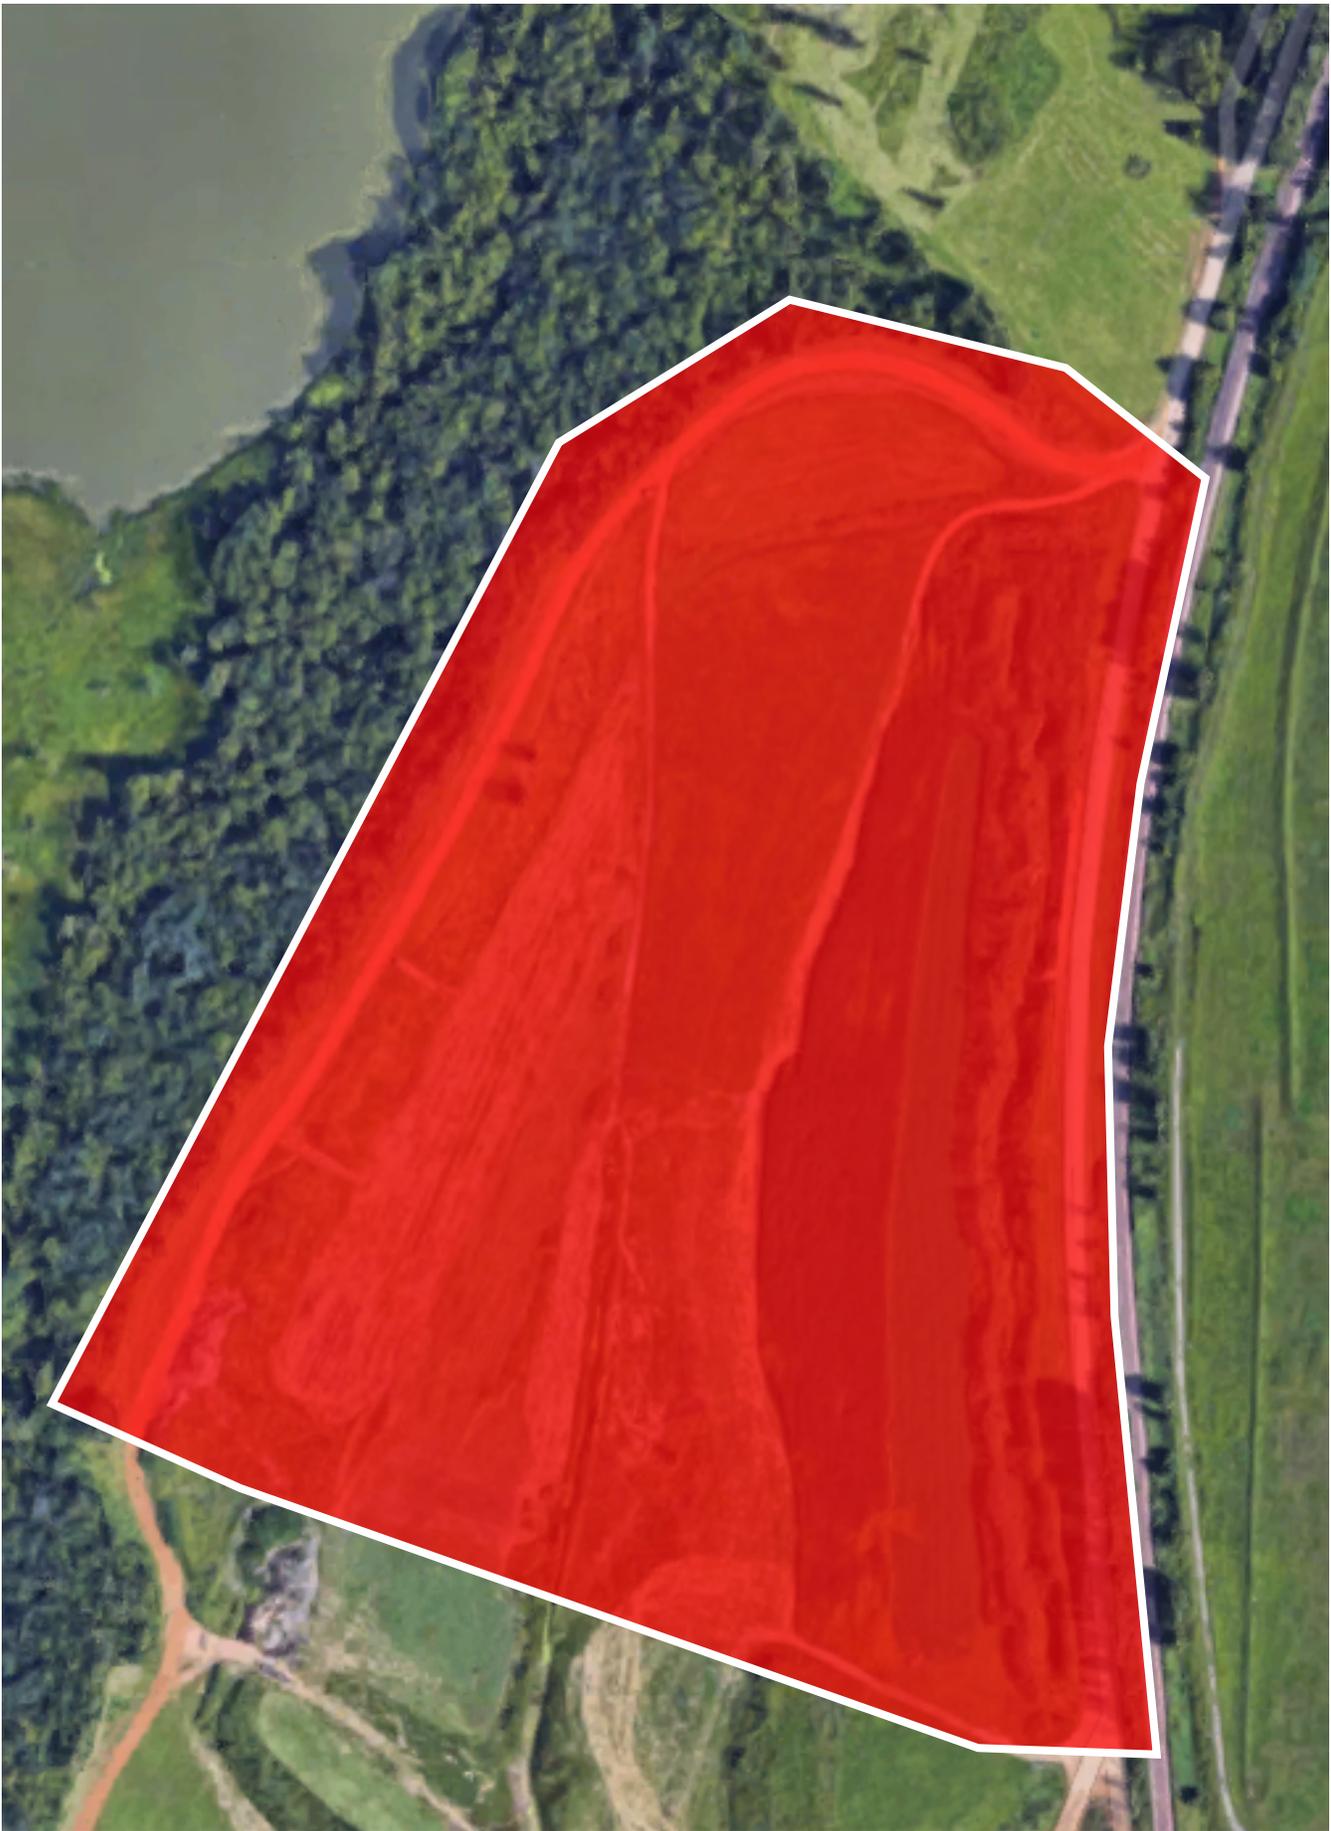
**Exhibit I -  
Map of North Quarry on Malkerson  
Sales Property**

The North Quarry was mined years ago and has been backfilled, sloped, and vegetated. Through visual observation and discussion with the property owner, this area was determined to be completely disturbed and no suitable locations for SSTS sites could be documented (Exhibit I). Previous mining occurred in this area and remnant spoil piles were visible along the perimeter of the mine. An internal access road was created through this area and many yards of fill soil were brought in and placed along the western edge of the North Quarry perimeter.

Not suitable  
for Type 1  
SSTS Sites

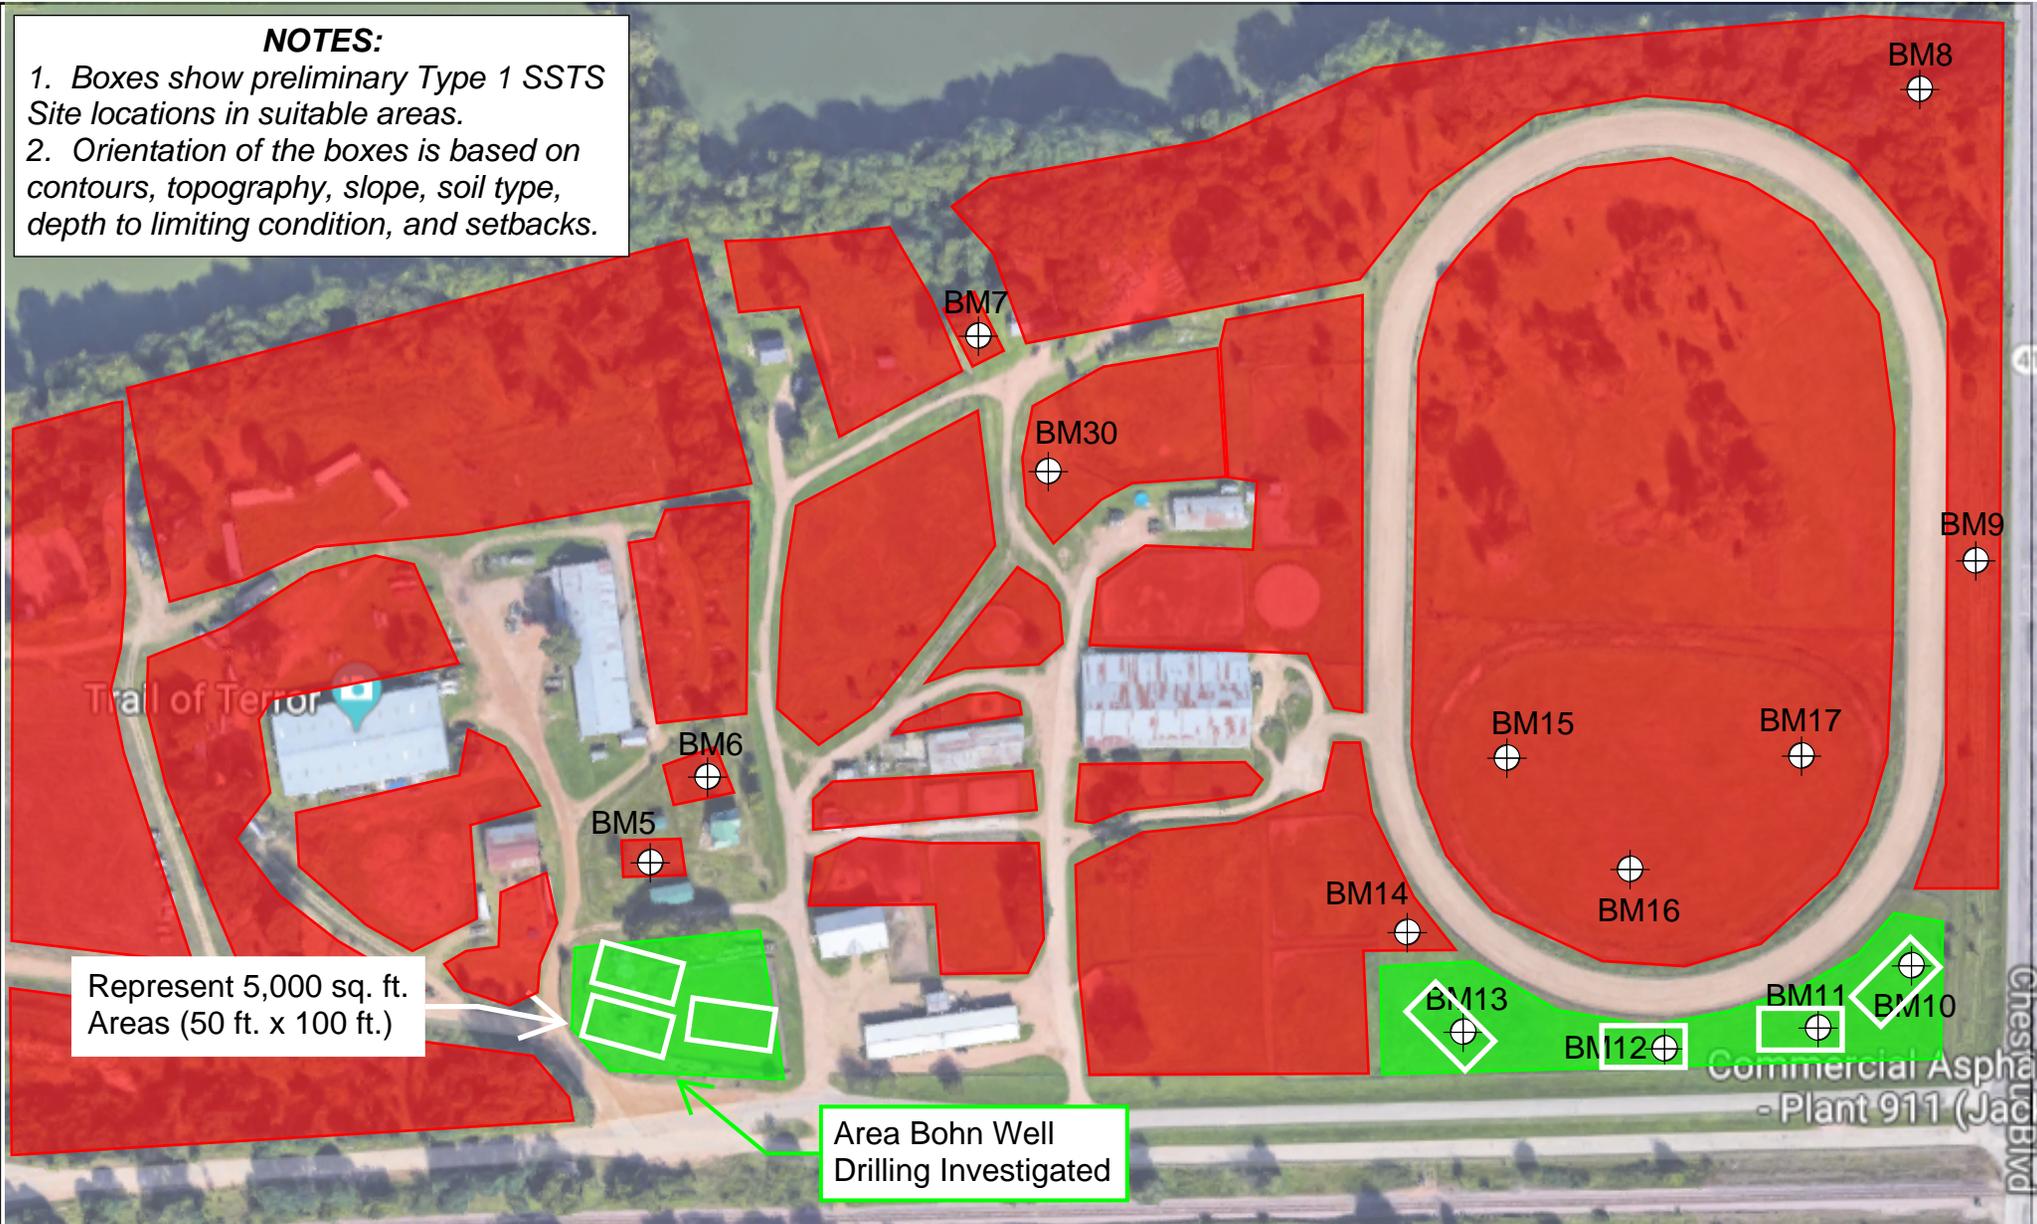
**Exhibit L -  
Map of Stable Area on Malkerson Sales Property**

This area consisted of many internal access roads, buildings, sheds, barns, houses, mobile homes, fenced in pasture areas for horses, and a horse training track. There were many locations in the stable area that were evaluated (Exhibit L). Of the areas evaluated only two locations met the criteria for suitable Type 1 SSTS sites. The first area is located southeast of the horse training track and the second location is in an open area just northwest of the main haul road. Bohn Well Drilling previously did soil borings in this location when investigating a potential site to serve the MS-N plant site and had them verified with Scott County Environmental Services staff. The locations that did not meet the criteria were deemed insufficient for one of the following reasons: (1) compacted soils, (2) disturbed soils, (3) less than 12 inches of suitable soil above the bedrock, or (4) not enough square footage available.

The area located southeast of the horse training track conceptually has the potential to support four 5,000 sf or two 10,000 sf SSTS sites. The area to the south conceptually has the potential to comfortably support three 5,000 sf or one 10,000 sf SSTS sites. There is enough total square footage available to potentially support four 5,000 square foot areas or two 10,000 square foot Type 1 SSTS sites but additional onsite work during the time of platting would need to be done to confirm that. Based on the depth to the limiting condition the type of septic systems that would need to be installed here would be mounds for all areas except the south half of the area by the horse training track. This area could support at-grade septic systems.

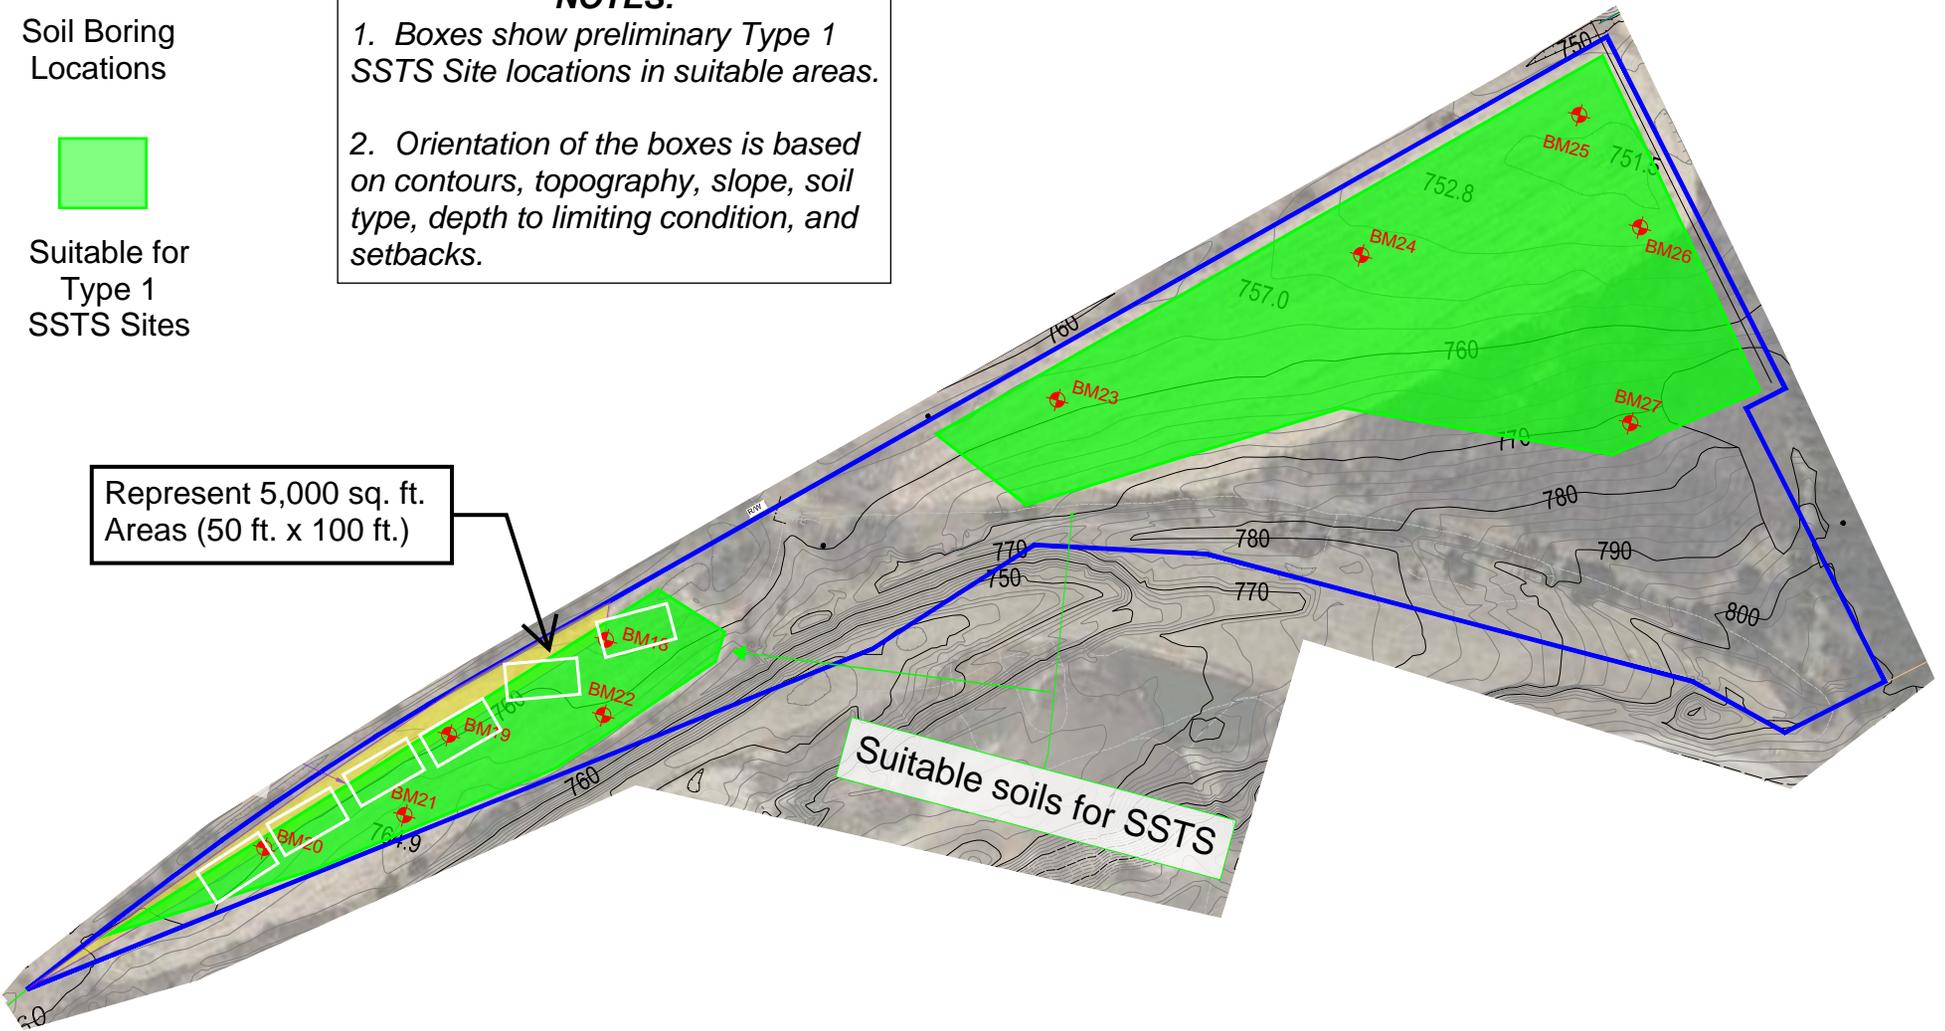
**Exhibit M - Map of Triangle Future Sand and Gravel Mine Area on Malkerson Sales Property**

This area is located on the southeast side of the railroad tracks (Exhibit N). A portion of the parcel is currently being farmed in row crops and a portion of the parcel is a wooded slope.

The old highway 41 alignment previously passed through this parcel. The roads original alignment remains as an access road that splits the parcel into two sections. Both sections were evaluated, and ten soil borings were described. All ten soil borings met the required criteria set forth in section 5.0 above and therefore have suitable areas that could accommodate Type 1 SSTS sites (Exhibit M). The size, shape, and topography of this parcel lends itself to one to three industrially zoned parcels. There is sufficient area on this parcel to support six 5,000 sf or three 10,000 sf SSTS sites. Based on the depth to the limiting condition the type of septic systems that would need to be installed here would be mounds.

Suitable soils for SSTS
