WATER QUALITY PROJECT FACT SHEET

PICHA CREEK STREAM RESTORATION

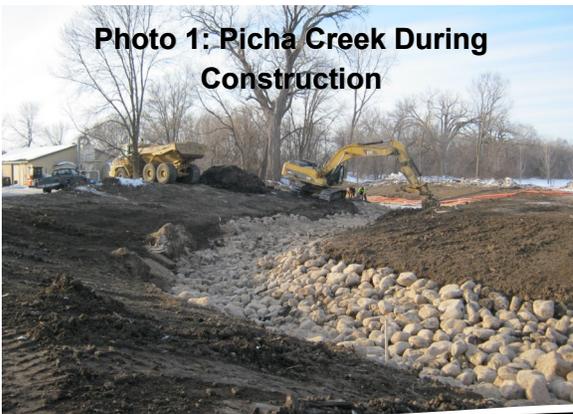
Photo 1: Picha Creek During Construction

Because Picha Creek had cut deeply into the earth, several strategies were used to stabilize and restore the stream's integrity. The channel was elevated and the floodplain widened in some places. The banks were stabilized using biodegradable materials

and native plantings. Buried grade controls and cobble riffles further slowed the water and stabilized the stream meanders (curves). This project also removed a fish migration barrier to help fish habitat fragmentation.

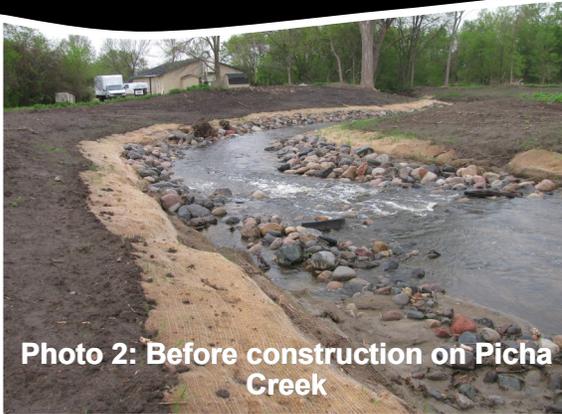
Photo 2: Before construction on Picha Creek

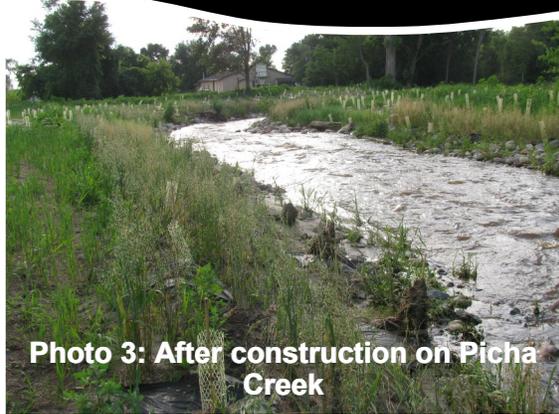
Photo 3: After construction on Picha Creek

- A fish migration barrier was removed.
- In-stream fish habitat incorporated.
- 1/2 mile of stream channel was restored to natural vegetation and the floodplain shelf was widened.
- This project reduced an estimated 900 tons of sediment and phosphorus per year from entering the Sand Creek watershed stream network.

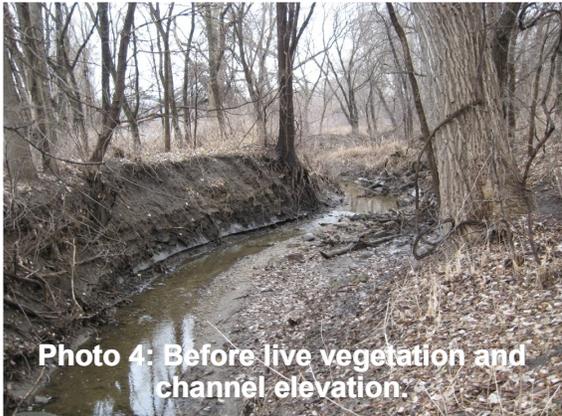
Photo 4: Before live vegetation and channel elevation.

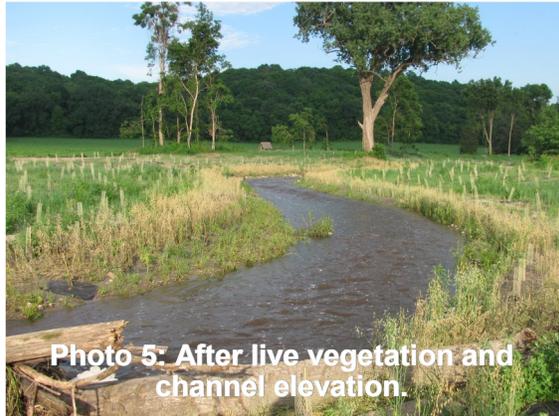
Photo 5: After live vegetation and channel elevation.

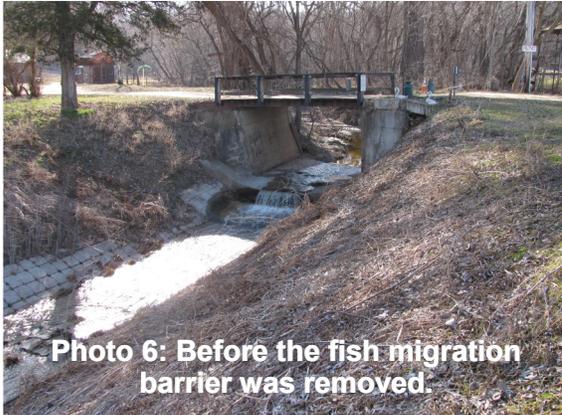
Photo 6: Before the fish migration barrier was removed.

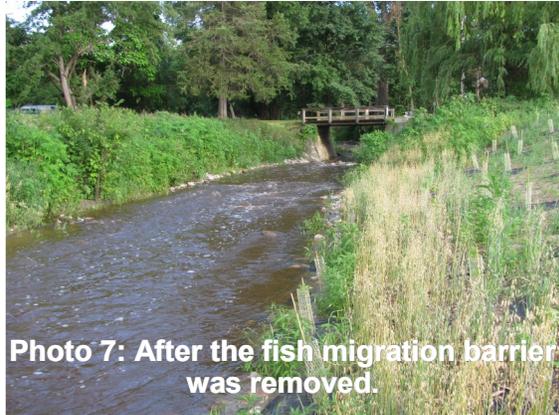
Photo 7: After the fish migration barrier was removed.
