SAND CREEK NEAR CHANNEL SEDIMENT REDUCTION

Feasibility Report

October 15, 2015

Prepared for:
Scott County, MN
Watershed Management Organization

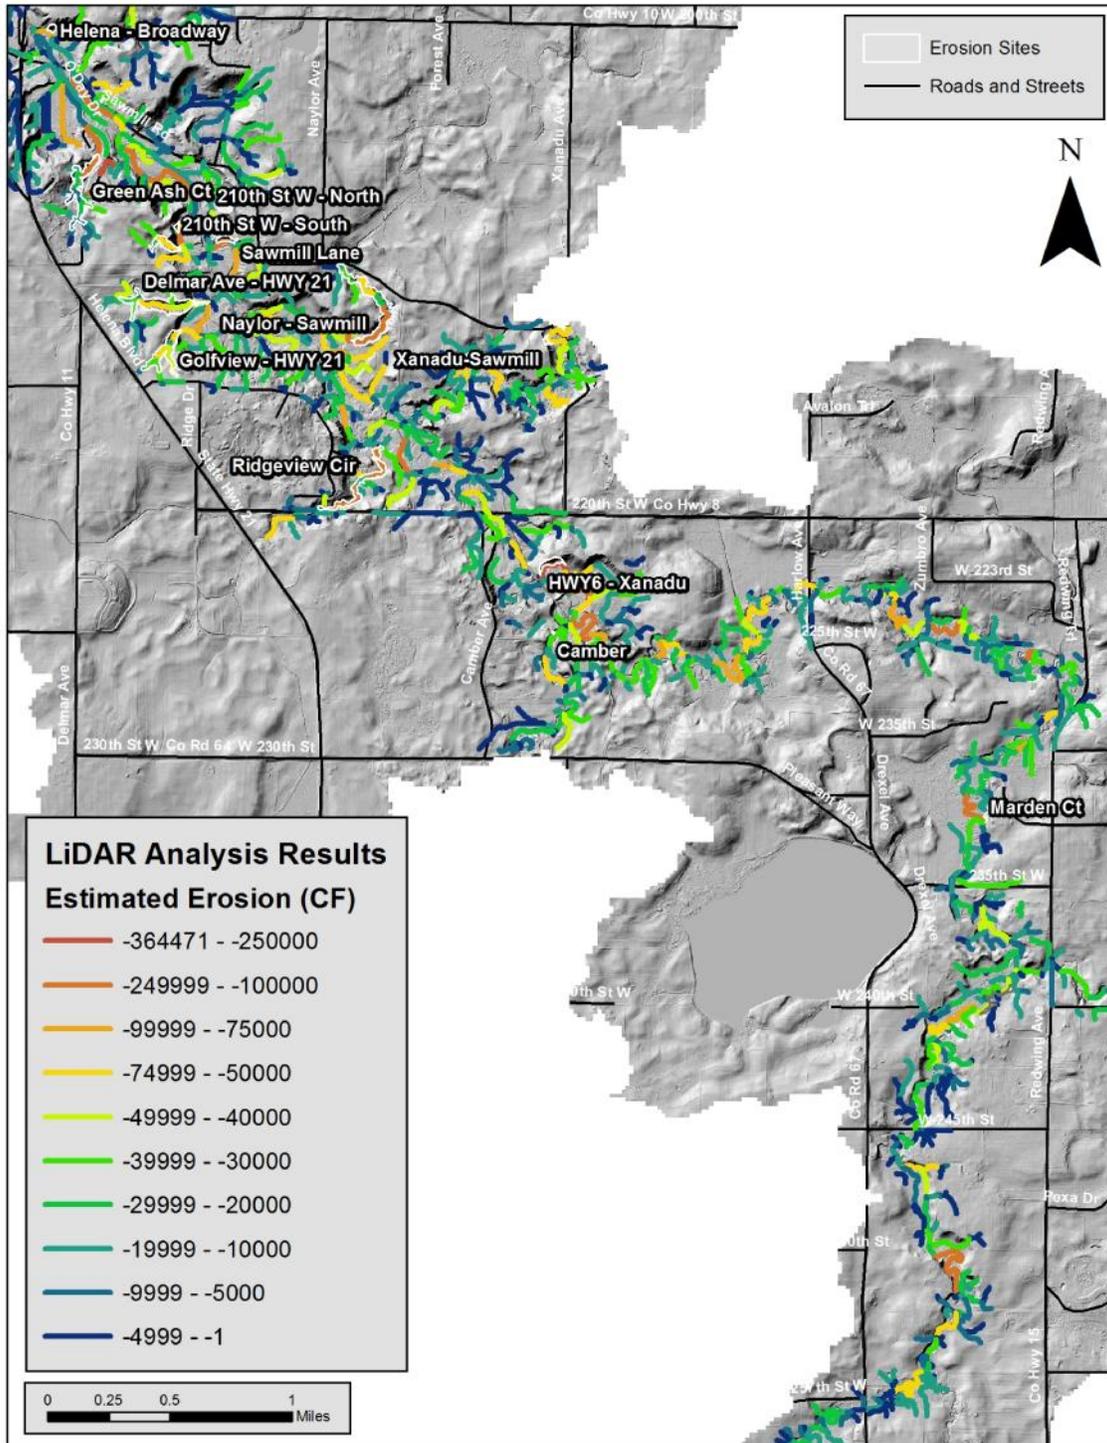
Figure 7. Estimated erosion within the Sand Creek system in Scott County (South) based on LiDAR geomorphic change analysis. High erosion areas are located along ravines between Jordan and County Highway 8, and at bluff sites along most of Sand Creek, but especially downstream West 235th Street. Bank erosion in “non-bluff” reaches also occasionally produces significant volumes of sediment.

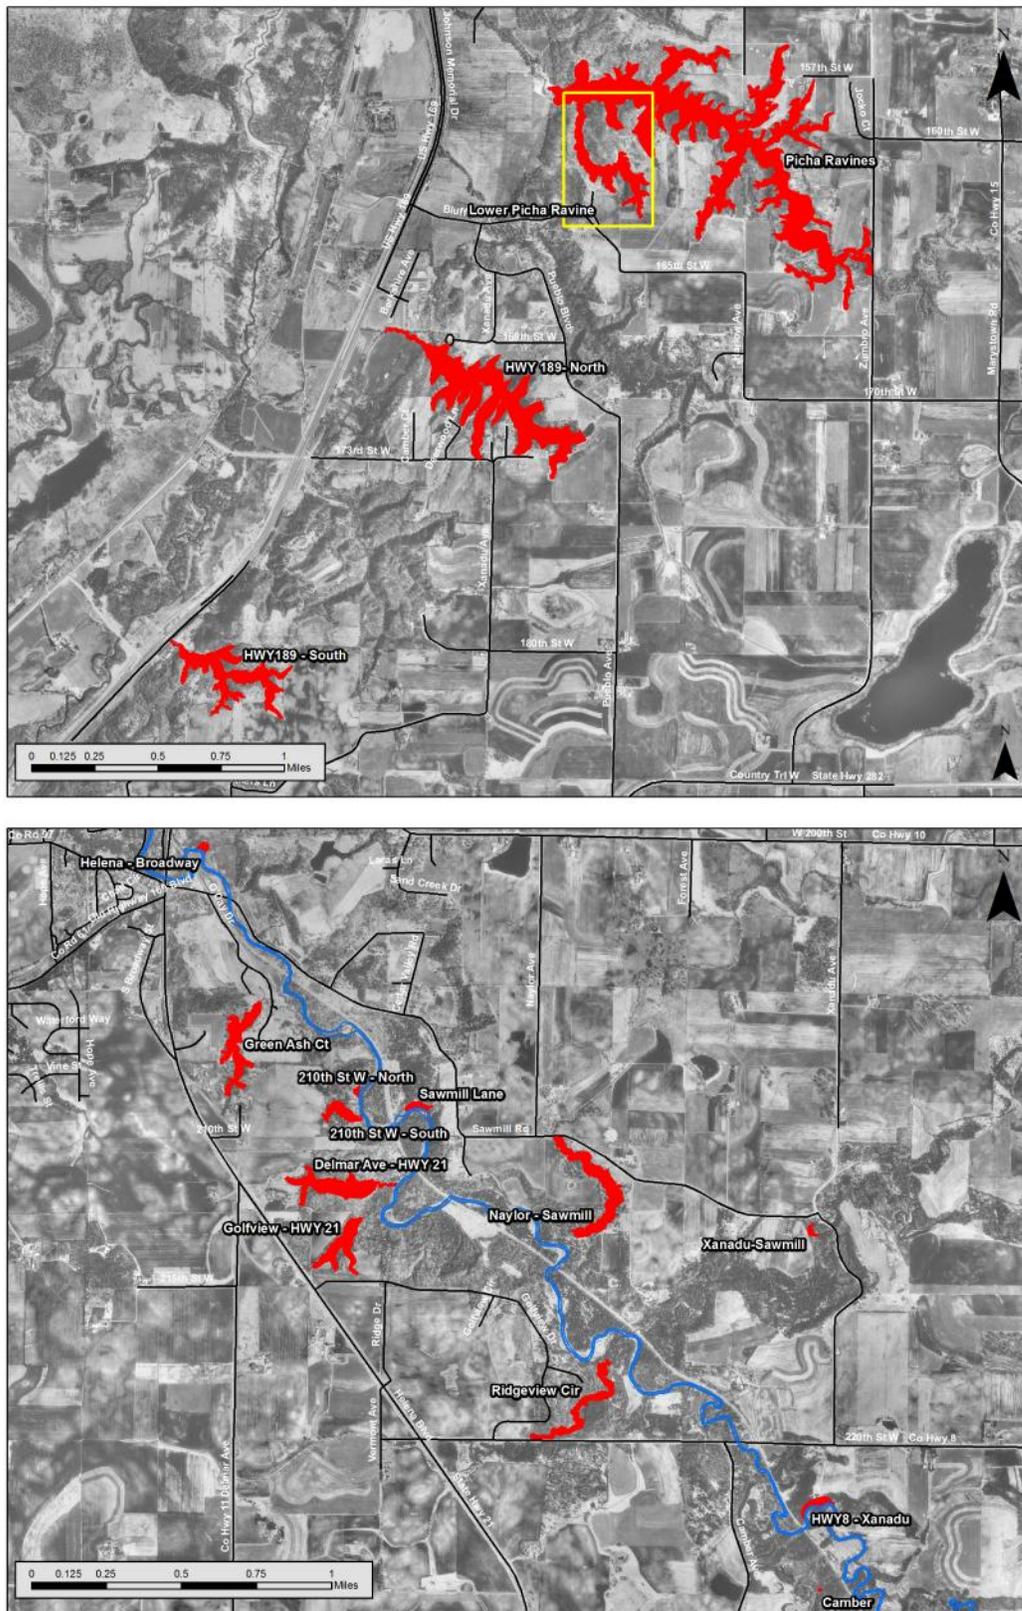
The sites in Table 2 and Figure 8 include reaches with the highest amount of sediment production, including the Ridgeview Circle and Highway 169-North ravine areas, and the bluff at Highway 8-Xanadu, which produce more than 800 CY of material per year according to the LiDAR analysis. Smaller sites, such as the Helena-Broadway and 210th St W – North sites, appear to produce less overall sediment, but have relatively high erosion rates for their size (>0.2 CF/SF/YR). The list includes a mix of bluff and ravine sites in both the north and south sections of the study area.

Figure 8. Site map of major erosion sites identified in LiDAR analysis and evaluated in the overall site prioritization (Tables 2 and 3).

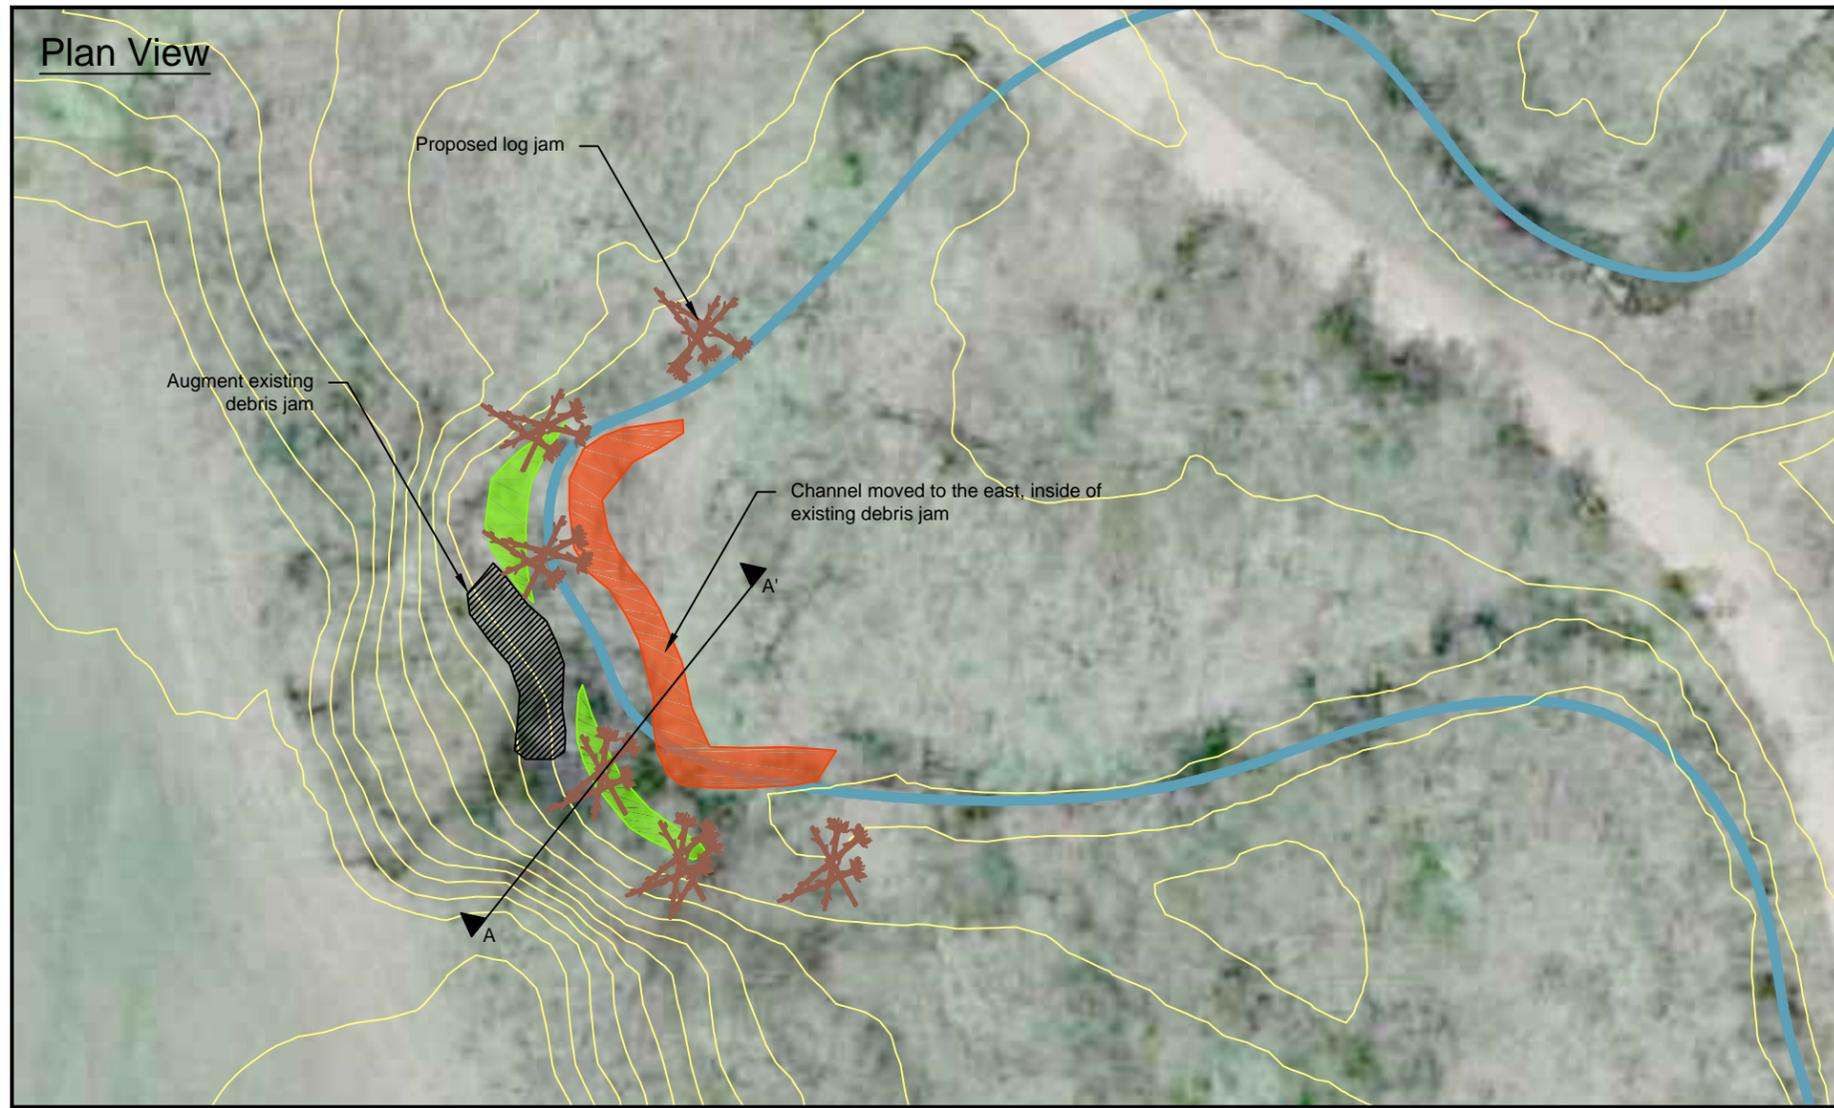
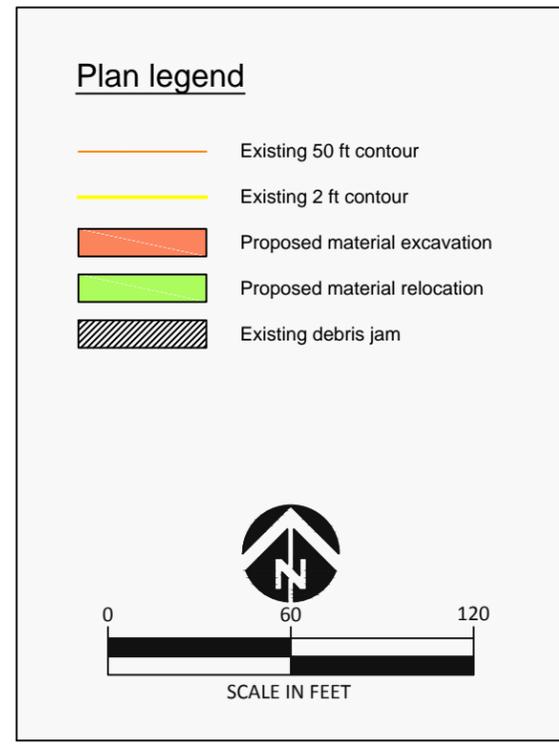
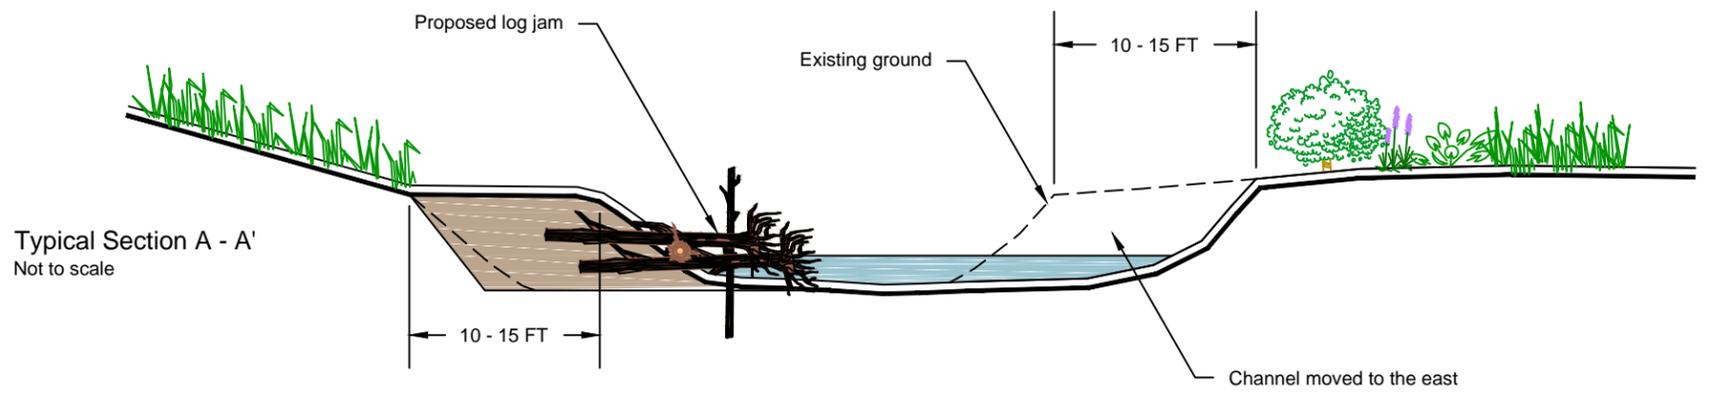
Xanadu HWY 8 Proposed Conditions
 September 16, 2015

The Highway 8 – Xanadu Site is one of the highest sediment producing areas along the channel. It consists of two failing slopes. The upstream bluff recently failed and appears to be highly unstable (Figure 23). The downstream bluff is steep, with debris cones and rills along the face, but does not appear to be actively collapsing (Figure 24). The site occupies a large compound bend along Sand Creek, and the failures are likely related to toe erosion along the outside of the bend. A residence/business occupies the top of the bluff and structures are often within 100 feet of the slope break.

The proposed treatment (Appendix E, Sheet 6) includes toe stabilization, but it is recommended that if this approach is taken, that either the slope be excavated or the infrastructure adjacent to the upper slope be moved to allow for natural failure of the upper slope. We have not included active excavation design in the concept plans, but excavation is included in the estimated costs for the project (Appendix E).
