# Credit River, MN

## Final Report - Fluvial Geomorphic Assessment

March 5, 2008

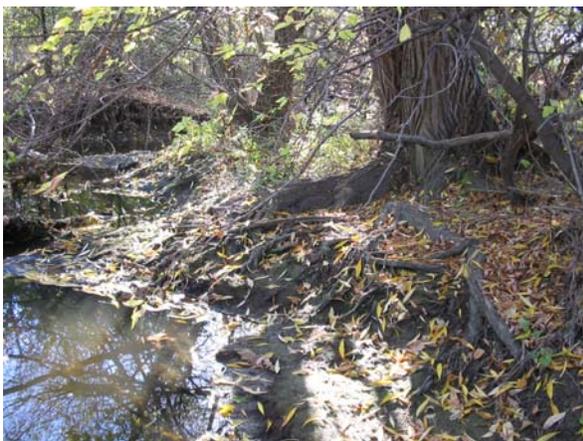
Figure 34: The root structure of trees hold the bank material together to stabilize the banks against rapid erosion.

New and existing landowners in forested reaches should be encouraged to remove exotics such as buckthorn and garlic mustard, but to otherwise leave the streamside vegetation to manage itself (Figure 34). This encourages natural stabilization and habitat formation. In most cases, our best intentions are actually detrimental to the stream environment. Erosion and deposition of streambank sediment are the essential physical forces behind stream and floodplain formation. Some degree of bank erosion is natural.
