## **Section 2: Watershed Characterization**

This section summarizes the physical characteristics of the Credit River Watershed in terms of topography and drainage, soils, geomorphology, aquatic habitat and wetlands, and land use. Most watershed characteristics are documented in GIS coverages. Maps of some of these characteristics are included in this Plan where the visual image provides meaningful information.

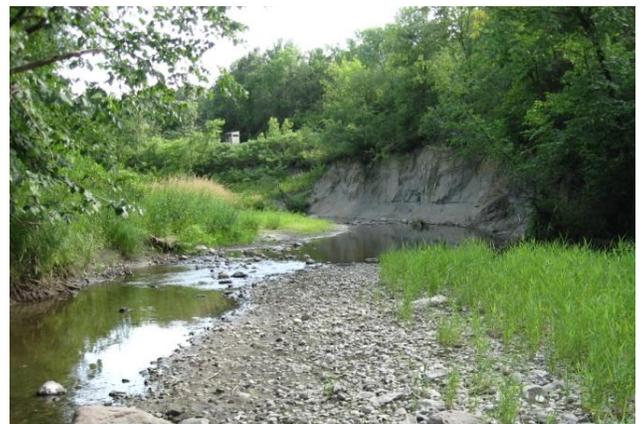
**Figure 2-5: Erosion along a cut bank and deposition on a point bar on Sand Creek**

Stable stream systems are in a delicate balance between the processes of erosion and deposition. Streams are continually moving sediment eroded from the bed and banks in high velocity areas such as the outside of meander bends and around logs and other stream features. In the slow water at the inside of meander bends or in slack water pools, some of this material is deposited. This process of erosion and deposition results in the migration of rivers within their floodplains. The process by which streams meander slowly within the confines of a floodplain is called *dynamic equilibrium* and refers mainly to this balance of sediment erosion and deposition. Streams typically have reaches that fall along the continuum of degradation (eroding) to aggradation (depositing) at any one time in the scale of channel evolution. The location and character of these individual reaches changes over time. When a stream channel is in equilibrium, it may move across the floodplain, erode and deposit sediment, but general planform geometry, cross-sectional shape, and slope remain relatively constant over human lifetimes (Figure 2-5).
